# Manhole Inspection Summary

Manhole # S23M\_\_003MH

Insp Date: **6/17/08 10:45 AM**

**Location** Address: **1543 Cole St**

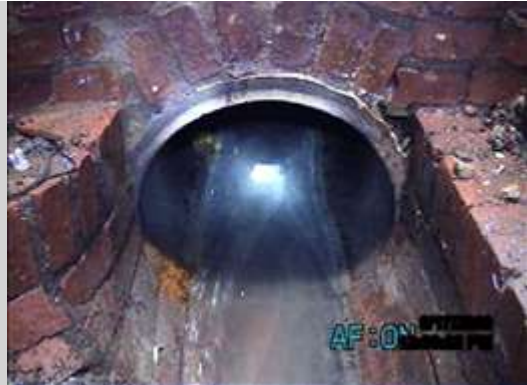
12 O'Clock Outflow

Pipe Height: **15.6** (in.) Rod and Bar (Angled)  
Pipe Material: **Clay** ☐ Pipe Lined  
Invert Depth: **16.59** (ft.) Flow Characteristics: **Fast**  
Deposits: ☒ None ☐ Mud ☐ Sludge ☐ Debris ☐ Grease  
Silt Depth: **0** (in.) Deposits Extent:  
Infiltration: **None** Pipe Seal Cond: **Sound**

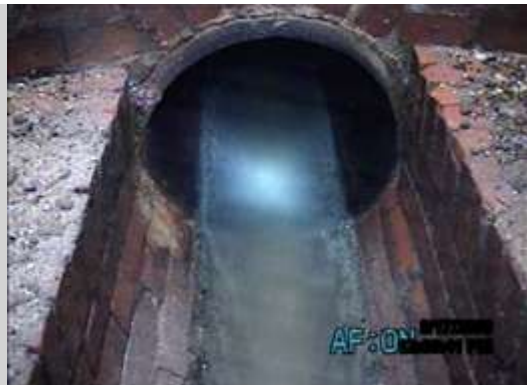
6 O'Clock Inflow

Pipe Height: **15.6** (in.) Rod and Bar (Angled)  
Pipe Material: **Clay** ☐ Pipe Lined  
Invert Depth: **16.47** (ft.) Flow Characteristics: **Fast**  
Deposits: ☒ None ☐ Mud ☐ Sludge ☐ Debris ☐ Grease  
Silt Depth: **0** (in.) Deposits Extent:  
Infiltration: **None** Pipe Seal Cond: **Sound**

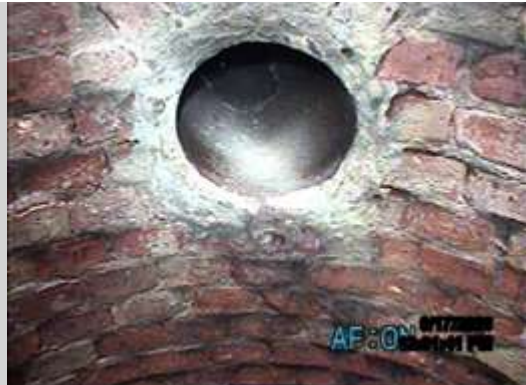
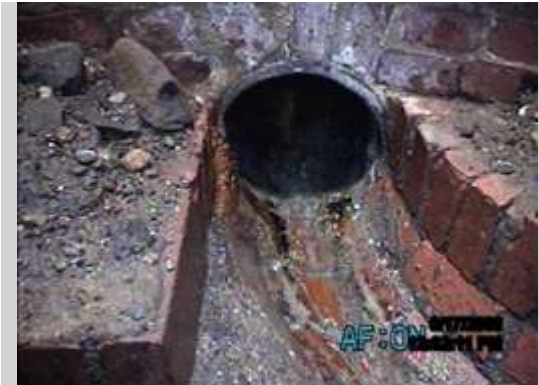
9 O'Clock Inflow

Pipe Height: **8.4** (in.) Rod and Bar (Angled)

Infiltration: **None** Pipe Seal Cond: **Sound**

Drop Condition: **Open**
